## REDUCED SUPERHEATER CORROSION BY INJECTION OF AMMONIUM SULPHATE IN A BIOMASS FIRED BFB BOILER

In this paper operational experiences concerning superheater corrosion during combustion of demolition wood in a Bubbling Fluidised Bed (BFB) boiler are evaluated. Parts of superheater SH2 were replaced due to corrosion after four years of operation. Injection of AS according to the ChlorOut concept was applied as a strategy to reduce the superheater corrosion in the boiler. Tube analysis after another two years of operation revealed that the superheater corrosion was significantly reduced after installation of the ChlorOut concept. These results were supported by long-term corrosion probe measurements carried out prior to installation during injection of ammonium sulphate and without any injection.

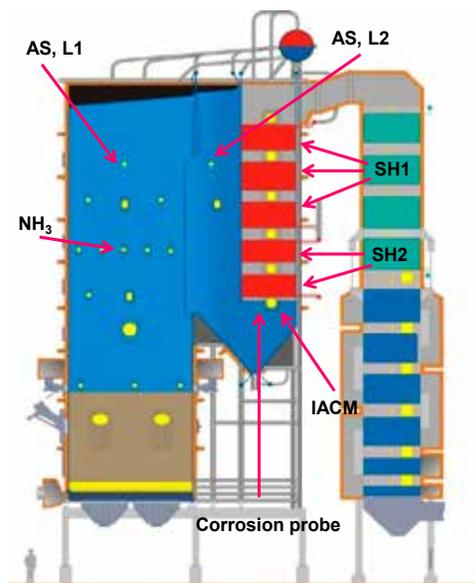
Fig. 1. The BFB boiler in Jordbro with locations for superheaters SH1 and SH2, the corrosion probe, IACM and injection points for AS and NH<sub>3</sub> indicated.

The injection levels for AS (L1 and L2), ammonia (NH<sub>3</sub>) and the location for IACM are indicated in Fig. 1. The injection positions for AS are in the upper part of the combustion chamber (Level L1) and in the upper part of the empty pass (Level L2). The boiler had a separate SNCR system for NH<sub>3</sub> before the injection system for AS was installed and it is still in operation. All positions for injection of AS and NH<sub>3</sub> are horizontal. The openings for IACM are located at the same position on the left and right side of the boiler.

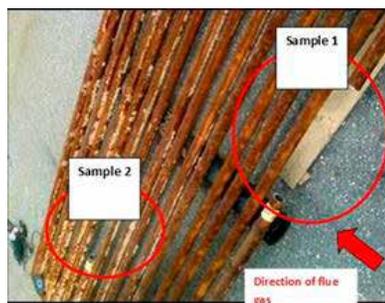
Fig. 2a. Superheater SH2 with positions for tube samples circled.

The boiler was initially operated without any additives to prevent deposit formation and superheater corrosion. The superheaters are made of low alloyed carbon steel. The first section of the primary superheater SH1 is made of 16Mo3 and the remaining sections are made of 13CrMo4-5. The secondary superheater SH2 has the highest out-going steam temperature and both sections are made of 10CrMo9-10. The locations of SH1 and SH2 are indicated in Fig. 1. The expected life-time for SH2 was approximately four years at the rather corrosive conditions prevailing in the superheater region during combustion of DWW. It was found during the regular inspection in the spring of 2014 that there was extensive corrosion in the lower, hottest part of SH2. The lower parts of SH2 were replaced after four years of operation during the following revision in the fall of 2014. In order to document the extent and nature of the corrosion, two tube samples were taken for analysis from the superheaters which had been removed. The position for these tubes are within the circles in Fig. 2a. A closer view of the tube samples is shown in Fig. 2b. The superheater SH2

consist of double tubes, and four rows of tubes from the bottom up are considered to form a coil in the superheater. Sample 1 is taken from tube row 1 in the lowest coil. Sample 2 is taken from tube row 10 from the bottom up. The flue gas flows from the bottom upwards, and steam flows in the opposite direction through the tubes, so that the temperature of the material is highest in the tube where sample 1 was taken.

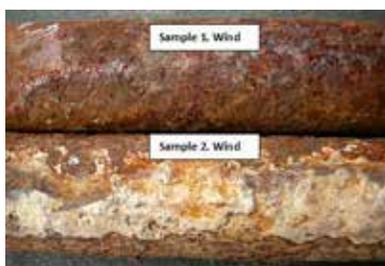
Fig. 2b. Close view of tube samples from SH2.

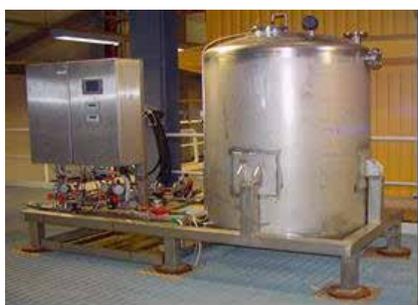
Fig.3a. Overview dosage system and intermediate storage tank

Fig. 3b. Injection of AS in Level L2

Fig. 3c. Nozzle with opening for AS and air

The permanent ChlorOut installation was fully implemented in regular operation of the boiler during the summer of 2014. It consisted of IACM for measurement of gaseous alkali chlorides, and a dosage system for injection of ammonium sulphate. The dosage system (Fig. 3) consists of an external 40 m<sup>3</sup> storage tank (outdoors), an intermediate storage tank, pumping and control units as well as lances and nozzles. An aqueous solution of AS (40% wt) is transported from the intermediate storage tank by a pumping skid to the injection lances and nozzle. The lances are located opposite each other at two injection levels.

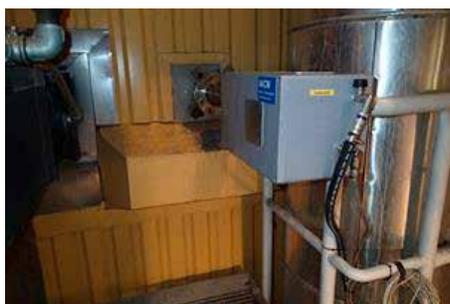
Fig. 4a. The lamp side of IACM in the boiler in Jordbro.

IACM (In-situ Alkali Chloride Monitor) is a measurement device which consist of a transmitter (lamp) and a receiver (spectrometer). The lamp sends UV-light over the flue gas channel (measurement path) to a spectrometer on the opposite side of the boiler wall. Fig 4a shows the lamp side of IACM installed in Jordbro and the spectrometer side of IACM is shown in Fig 4b. The light is absorbed at characteristic wave lengths depending on the concentration of certain gaseous species such as KCl and SO<sub>2</sub>. The measuring principle is Differential Optical Absorption Spectrometry (DOAS). The result is expressed as the concentration of KCl and SO<sub>2</sub> respectively in ppm and is obtained after data evaluation of a spectrum by the IACM computer. A more detailed description of IACM can for instance be found in Andersson 2006a, Kassman et al. 2010, Kassman 2012, Leffler et al. 2016.

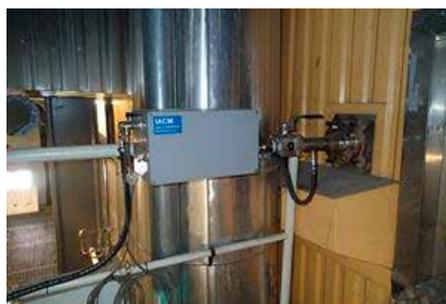
Fig. 4b. The spectrometer side of IACM in the boiler in Jordbro.

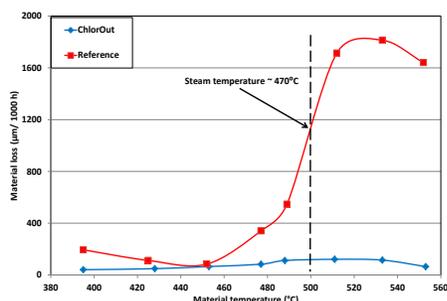
Fig. 5. Material loss during long-term corrosion probe measurements with (ChlorOut) and without (Reference) injection of ammonium sulphate.

Table 3 shows the basic test conditions during the corrosion probe measurements. The probe exposure time in the boiler was 716 hours in the reference case and 932 hours in the ChlorOut case. When taken out from the boiler the probes were covered with a thin layer of deposits, except on the wind side where it was thicker. The material loss during long-term corrosion probe measurements with injection of ammonium sulphate (ChlorOut) and without (Reference) is shown in Fig. 5. There was significant difference in material loss between *Reference* and *ChlorOut* at greater temperatures. The use of ChlorOut reduces the material loss from extreme values, ~1700 µm/1000 hours, above material temperatures 500°C to ~100 µm/1000 hours. During Reference, a steep increase in the corrosion rate was observed at material temperatures above 460°C. The outgoing steam temperature is 470°C for SH2, which corresponded to a material temperature for the wind side of 500°C during the long-term exposure. The corrosion rate was reduced by approximately 80% at a steam temperature of 470°C. The reduction in high temperature corrosion is well in line with the purpose with injection of ammonium sulphate. Measurements of gaseous KCl by means of IACM showed that KCl was lowered from 35 ppm during *Reference* to 12 ppm during *ChlorOut*. As a consequence less chlorine was present in the deposits on the superheater tubes which leads to a reduced corrosion rate during ChlorOut.

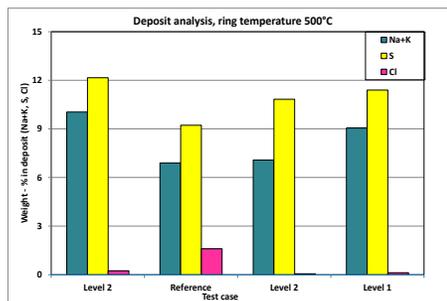
Fig. 6. Deposit analysis of Na+K, S and Cl at a ring temperature of 500°C.

Deposit measurement using a temporary injection system were carried out to optimise the dosage of ammonium sulphate regarding position and quantity, and also verify the effect by short-term measurements. The results obtained during short-term measurements showed that addition of AS reduced the content of KCl in the flue gases and also chlorine in the deposits. Fig. 6 shows the results from a deposit measurement

during a Reference as well as injection of AS in L1 and L2 respectively. Here the greatest content of chlorine was found during the Reference without injection of AS. These results also supported that injection of AS according to the ChlorOut concept could be applied as a strategy to reduce the corrosion rate of the superheaters in the boiler in Jordbro

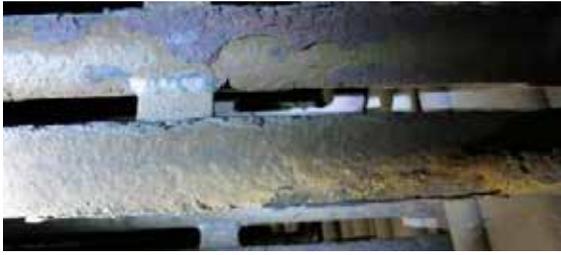
Fig. 7. Highly corroded tubes of SH2 after nearly four years without an additive.

Fig. 7 shows the appearance of tubes in the lower and hottest part of SH2 during a regular inspection in the spring of 2014. These tubes of low alloyed carbon steel (10CrMo9-10) were highly corroded and the oxides were loosely attached to the metal. The tubes in SH2 has an  $S_{Nom}$  of 6.3mm and the wall thickness was less than 4.0 mm in certain spot tests in the lowest row. The lower parts of SH2 were replaced after four years of operation during the following revision in the fall of 2014. Two tube samples were taken for analysis and the position for these tubes are within the circles in Fig. 2a. A closer view of the tube samples is shown in Fig. 2b and only isolated patches of the magnetite layer remained in place. The oxide on these patches was loosely attached and after being kept at room temperature for several days they became detached and fell from the tubes. These observations showed that the tubes have been subject to corrosion. This applied particularly to the lower (wind) side of sample 1, which was subject to the highest steam temperature and faced towards the incoming flue gas.

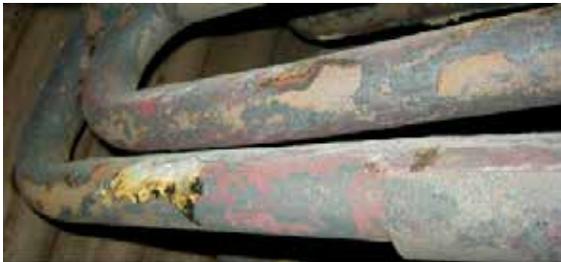
Fig. 9. SH2 after two years with ChlorOut..

Fig. 9 shows the appearance of tubes in the lower and hottest part of SH2 during a regular inspection in the fall of 2016 after two years of operation with injection of ammonium sulphate. Parts of the tubes were covered with a black magnetite layer ( $\text{Fe}_3\text{O}_4$ , iron oxide) which was tightly attached to the tube material. There were also a hematite layer ( $\text{Fe}_2\text{O}_3$ ) outside the magnetite and hematite is less attached to the material. There is an area in the left part of Fig. 9 with yellow corrosion products (iron chloride,  $\text{FeCl}_3$ ) on the surface. The iron chloride could have been formed under oxides during operation or after the blasting during the outage. Further to the left, there is a clean metal with smooth surface which indicate no local corrosion has occurred here. In Fig. 10 a closer view is taken of the wind side of a typical tube in the lowest row of SH2. Spot checks of the wall thickness were taken on-site during the inspection and these results might be somewhat inaccurate compared to the ones from the tube samples. The overall corrosion during the first two years of operation was less than 0.5 mm. This means the corrosion rate with injection of ammonium sulphate according to the ChlorOut concept was less than a third of it without any additive. The results from tube analysis were supported by long-term corrosion probe measurements as well as deposit probe measurements carried out prior to installation. This means these measurement tools could be applied together with IACM to predict the corrosion rate.
